CAP Inspection Log

Property Inspected: Union Pacific Railroad Parcel A – Harbor Island, WA

Date/Time of Inspection: 28 December 2017, 0900-0910

FIELD PHOTOGRAPHY LOG SHEET
2017 UPRR Cap Inspection – Harbor Island (Parcel A)
Seattle, Washington

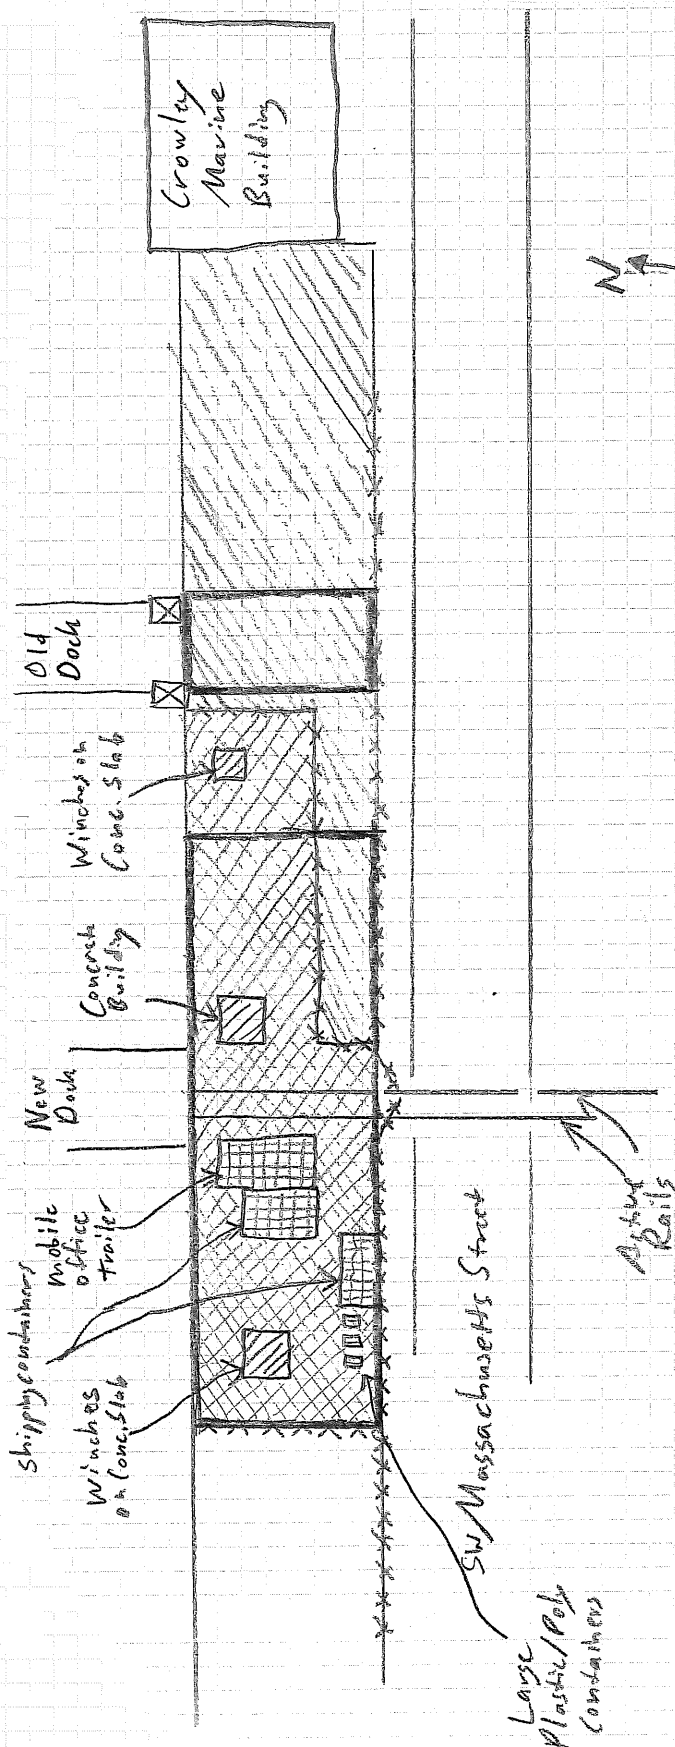
Figure 1 - Site Plan

General: The UPRR parcel observed is entirely capped and is compliant with EPA requirements (see attached Figure 1 – Site Plan and attached photograph log).

Pavement Cap Damage-Location and Description: No pavement cap damage was observed.

Settlement: No obvious sign of differential settlement of more than 1-inch was observed on the pavement. Minor settlement (less than 0.5 inches) was observed in several limited areas on the property.

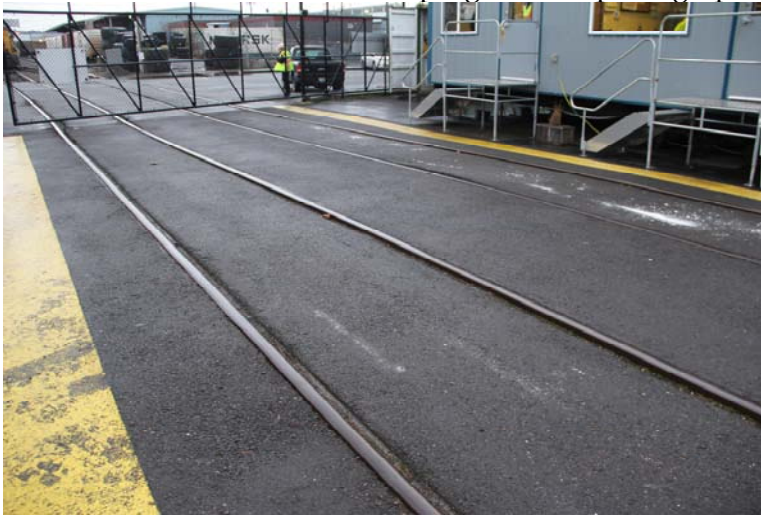
Photograph No. 1

Description: View of pavement with active rail lines on UPRR Parcel A. View is towards the southwest. Office trailer is in view at the top right of the photograph.

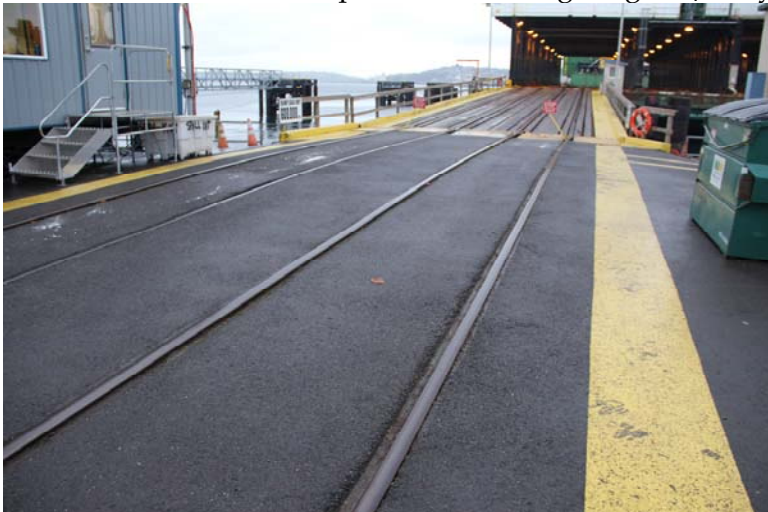
Photograph No. 2

Description: View of pavement with active rail lines on UPRR Parcel A. View is towards the north-northwest. Rail dock ramp and rail-hauling freighter/ferry is in view at top right of photo.

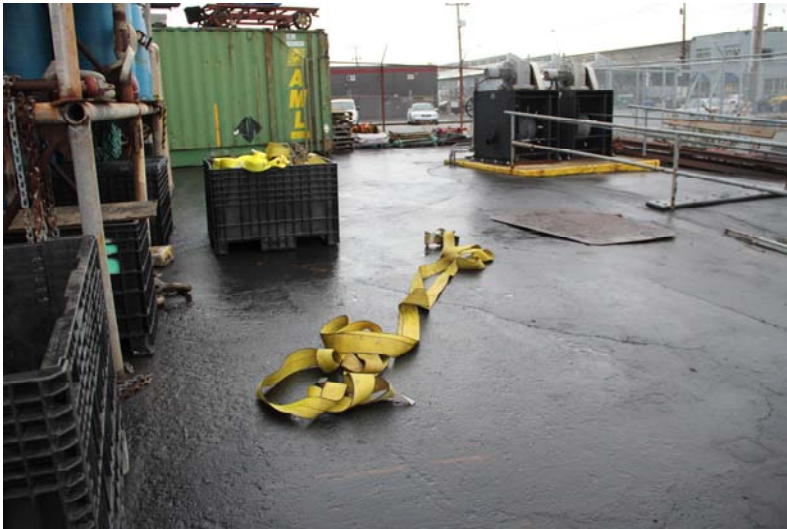
Photograph No. 3

Description: Photo looking across the western portion of the UPRR Parcel A. View is towards the southwest.
